Re: October 2011 Monthly Progress Report
Administrative Settlement Agreement and Order on Consent for Removal Action
U.S. EPA Region 10 Docket No. CERCLA 10-2009-0255
Gasco Sediments Site within the Portland Harbor Superfund Site

Attachment A Monthly Visual Monitoring Report for Pilot Cap Vicinity

Visual Observations Log Form

Monitoring Period: Monthly (Year 5)—October 2011

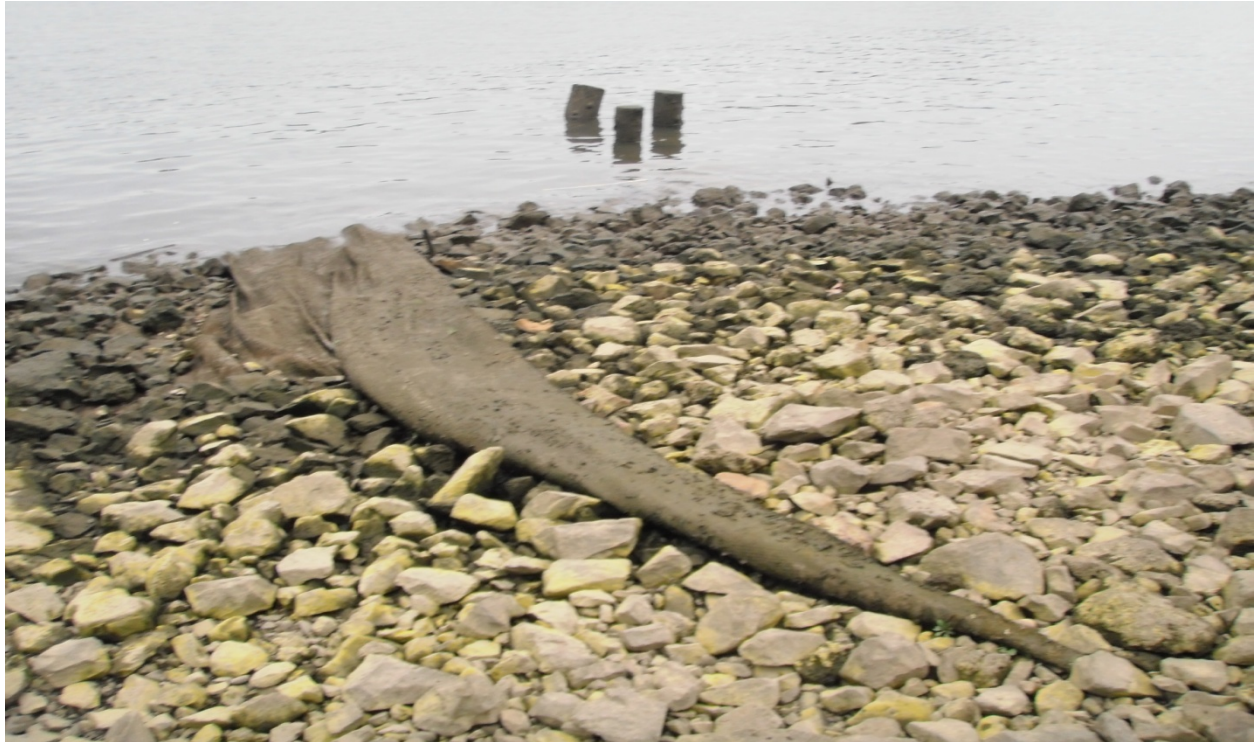
Observations of Erosion/Deposition: No erosion/deposition is evident along the shoreline. Four organoclay mat material segments are exposed and visible. One section of organoclay mat is 20 feet in length and is visible at the upriver extent of the cap area (Photo 1). Near the midpoint of the cap area shoreline, two segments 4-foot and 2-foot in width are exposed approximately 10 feet from the water's edge. A 30-foot section of mat material is exposed near the downriver extent of the cap.

Photo 1—*exposed section of organoclay mat, perpendicular to the shoreline near upriver extent of cap area (10/13/11):*

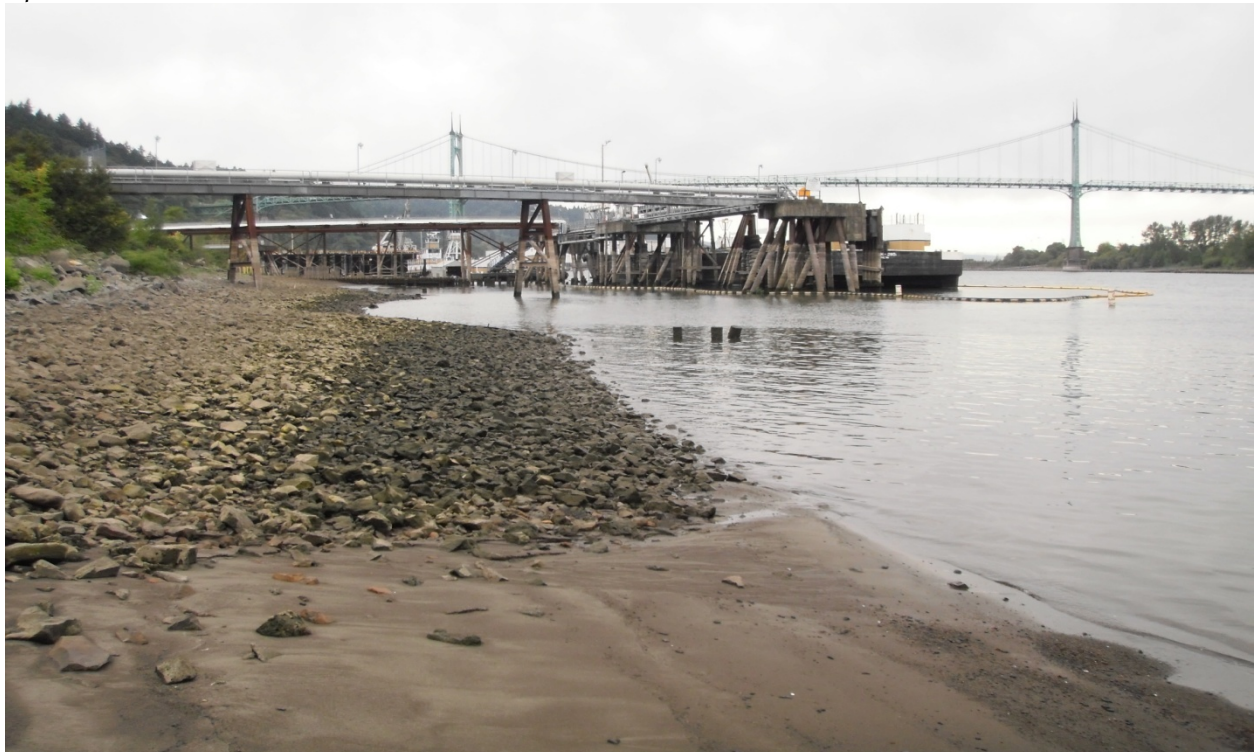
Observations of Long-term Controls (i.e., oil booms, organo-clay mat, etc.) During the observation, the Fuel and Marine Marketing (FAMM) containment boom was placed around a fuel barge moored at the ship dock. Buoys that identify the cap area to mariners are in place as installed. The position of the FAMM oil boom, warning buoys, and a general overview of the site shoreline is shown in Photo 2.

Photo 2 — *FAMM oil boom shown around fuel barge and mariner warning buoys in place across pilot cap area. (10/13/11):*

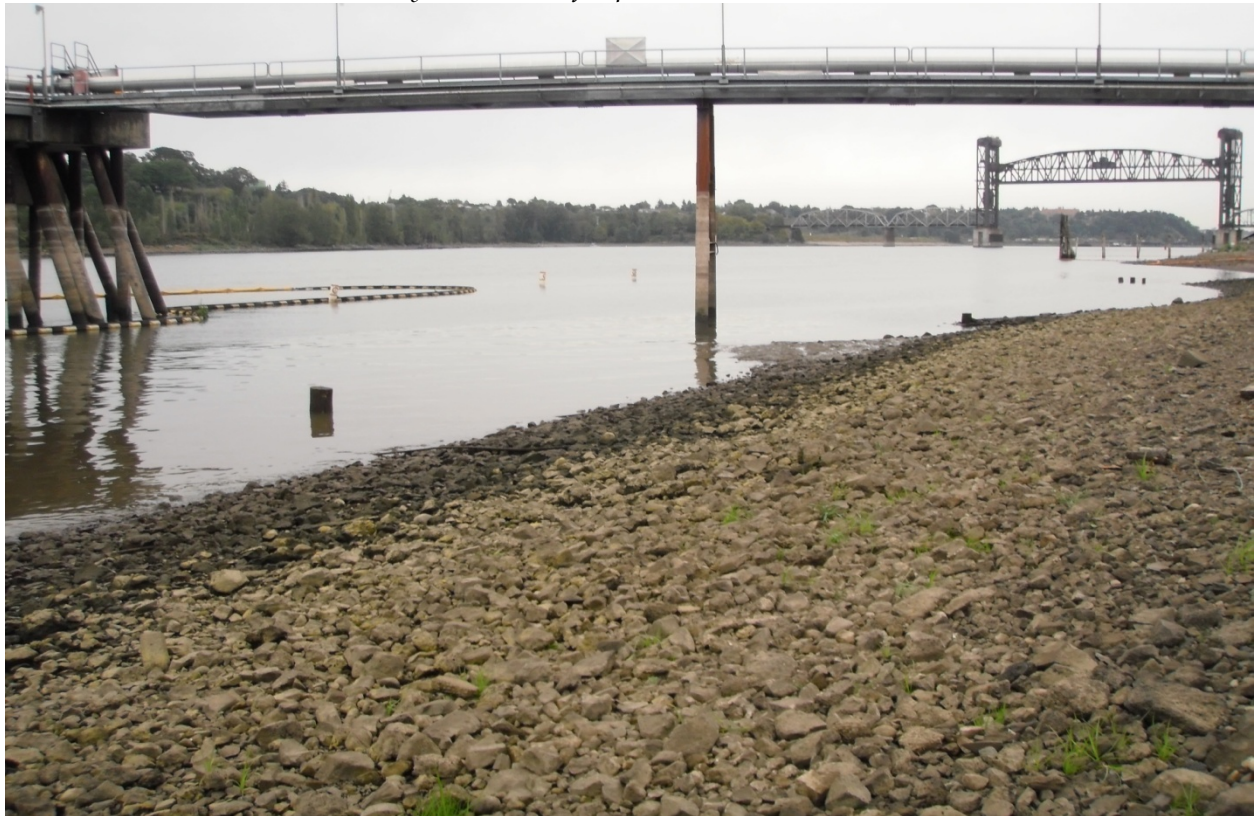
Other Comments: No sheen is evident in or around the cap area. Photo 3 shows the water surface and shoreline immediately downriver of the sediment cap.

Photo 3 — *Conditions immediately downriver of cap area (10/13/11):*
